Ignition Distributor - Install Ventilation When Serviced

9403

March 29, 1994

Ignition Distributor Ventilation

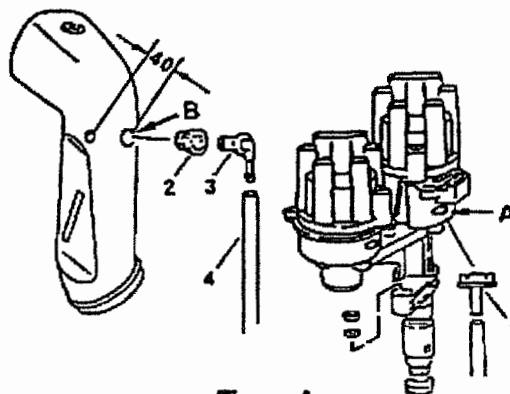
Figure A

Ventilation for ignition distributor must be installed if replacement of ignition distributor becomes necessary.

- Use a screwdriver to remove the oval plate (arrow A) on the ignition distributor.
- Install ventilation connector (1) into distributor.
- Remove air guide pipe.
- Drill an 18 mm diameter hole (B) 40 mm to the right of the tail light ventilation into the air guide pipe.
